The 750 kV power line at Zaporizhzhya Nuclear Power Plant shows no signs of major damage: new satellite investigation by Greenpeace

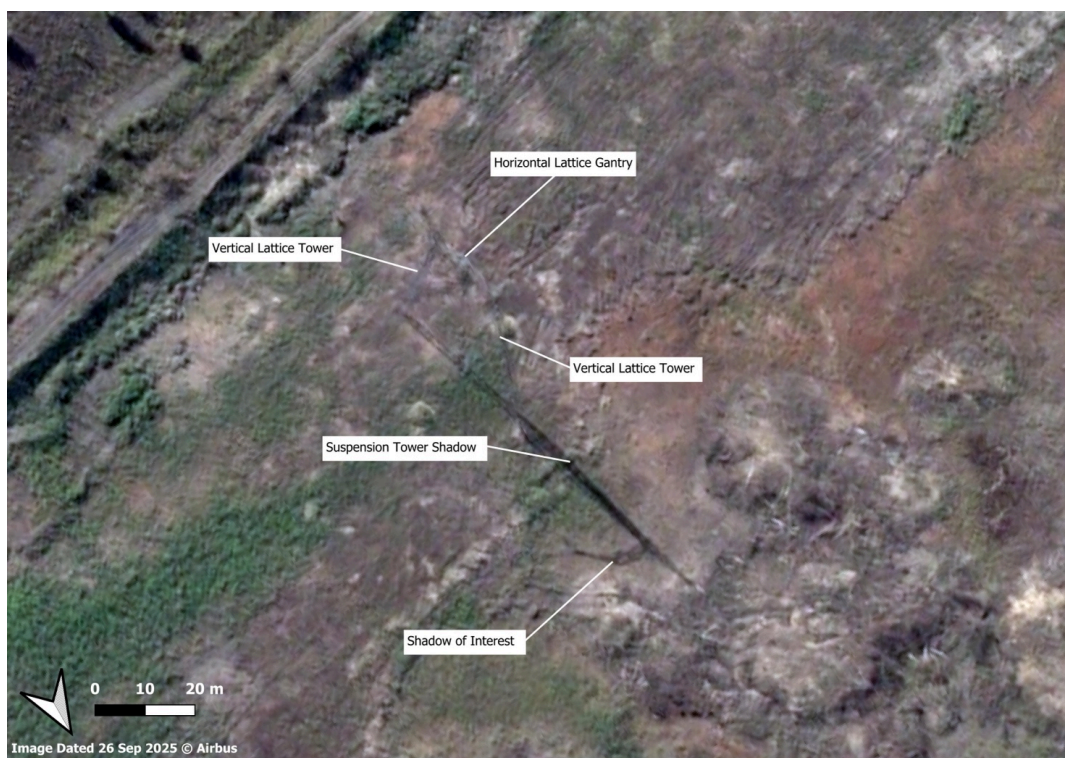
McKenzie assessed the area at the 'damaged' transmission tower which is located 1.9km to the northeast of the boundary at reactor unit 6 at ZNPP. McKenzie conclude that:

- The vertical 750kV lattice towers remain in position and upright. It also appears to confirm that the horizontal gantry is still in place connecting the two vertical towers;
- There is some uncertainty over a shadow in the image;
- The suspension tower remains in situ. It is still standing and therefore it should be a relatively simple task to repair;
- There is no evidence of any crater, either fresh or historic in the area surrounding the pylons and network of power lines in this part of the plant.
- The Ukrainian policy is not to conduct military strikes on nuclear power plants, which further undermines the claim that it is too dangerous to conduct repairs to the suspension tower;

“An analysis of the wider area does not support claims of incoming shelling of the area.”

1 October 2025, Kyiv...Former military remote sensing experts at McKenzie Intelligence Services (MIS) have reviewed high resolution satellite imagery from 26 September 2025 supplied by Greenpeace. [In their report \(1\)](#), MIS show **that there has been no shelling or attacks at the location of the 750 kV transmission tower. It is exposing Russia's false claims that the loss of external power at ZNPP is due to Ukraine military attacks.** McKenzie concludes that if there is any damage to the line at all, it is minimal and could be easily repaired.
