**Analysis of Russian Claimed Ukrainian Attacks  
against the  
Zaporizhzhia Nuclear Power Plant  
Commissioned by Greenpeace Ukraine**

**17 September 2026**

Proprietary:  
McKenzie Intelligence Services  
Commissioned by Greenpeace

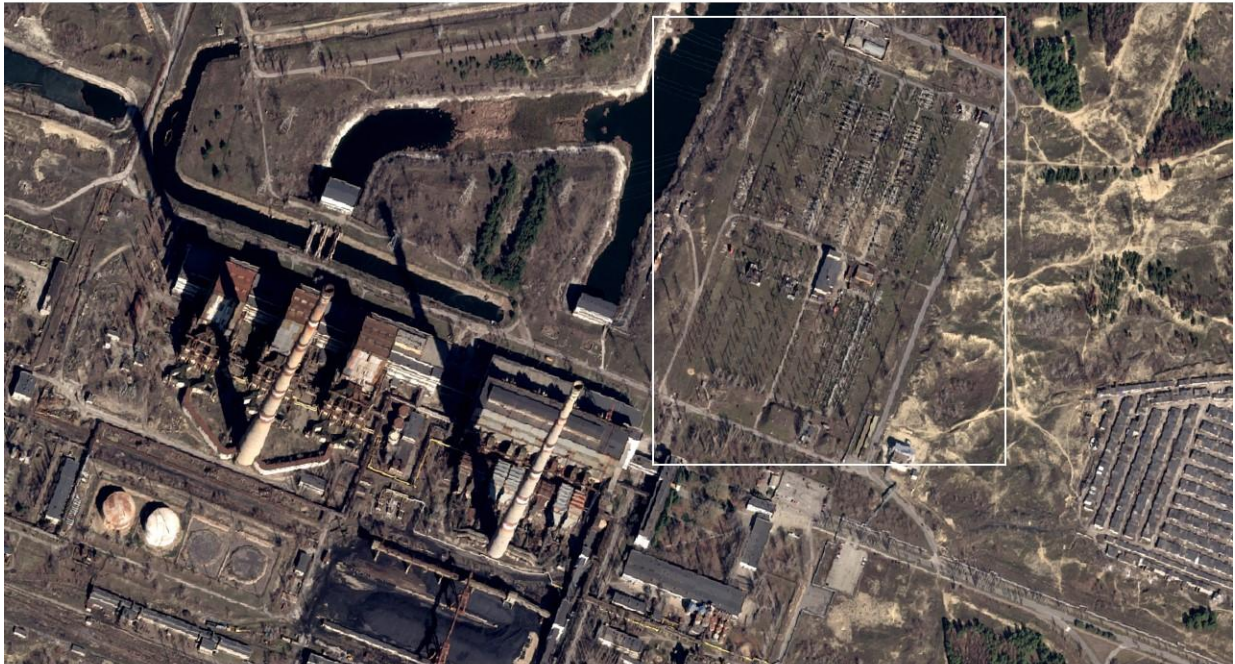
Fig. 1 - Location of Ferosplavna 330kV open switchyard. Image dated 15 October 2025

The Ferosplavna 330kV open switchyard is located to the north east of the ZTPP, and consists of a number of circuit breakers, switches and current transformers. See Fig. 1 below.

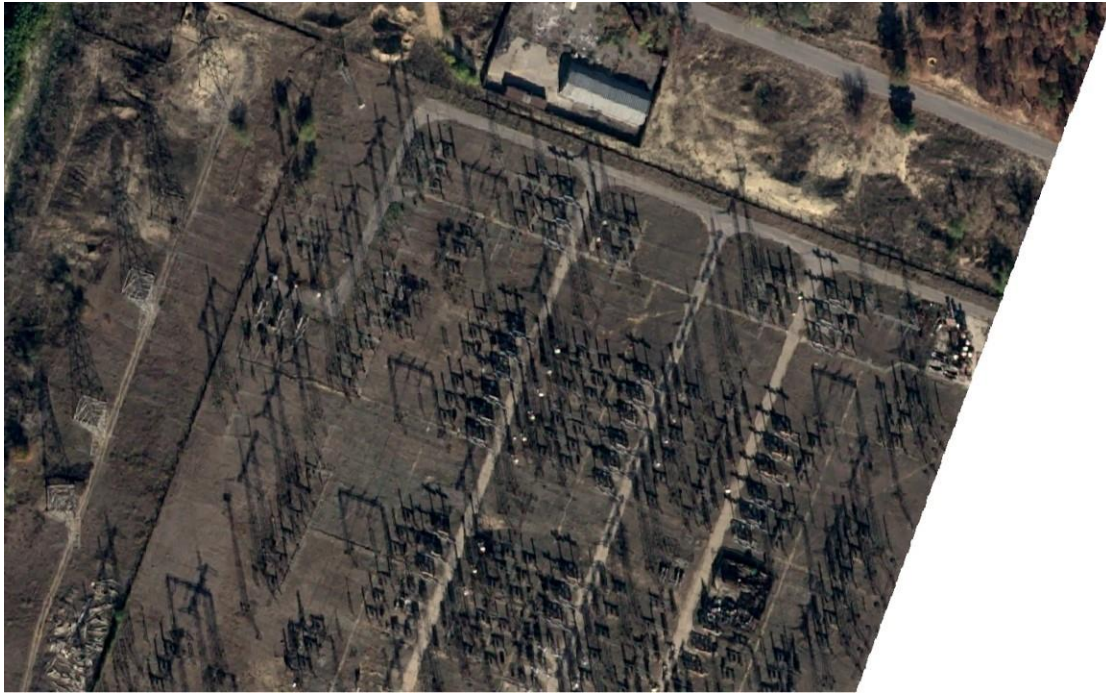
Fig. 2 – Area of interest dated 15 October 2025

There is a coherent change in one area of the open switchyard on imagery between 15 October 2025 and 27 February 2026. A small area of approximately 800sqm has a large amount of debris present. This is confirmed by the provided images from staff at ZNPP showing International Atomic Energy Agency (IAEA) observers overseeing removal of current transformers breakers and switches on 28 February 2026. The location of the provided image is confirmed by the presence of a distinctive building in the background. See Fig. 2 and 3 below.

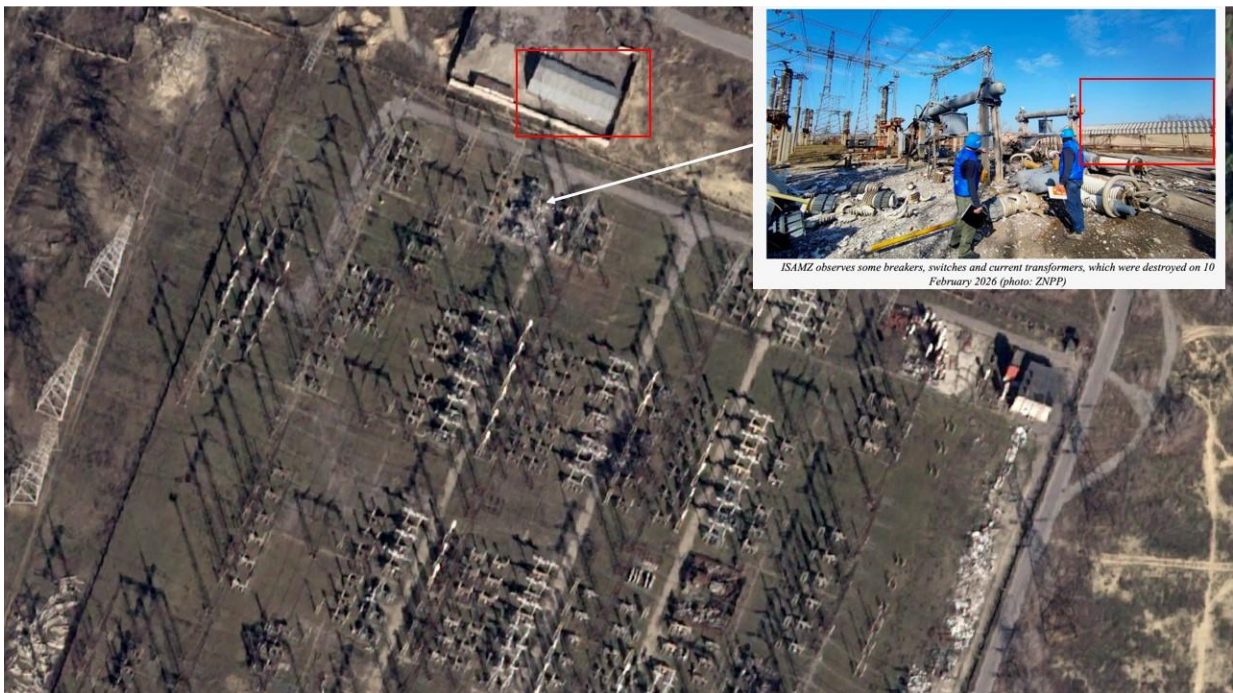
Fig. 3 – Area with debris dated 27 February 2026.

The Russian government claimed that the area was struck by upwards of 14 munitions in four strikes. Other than this small area, there is no evidence of damage across the Ferosplavna 330kV open switchyard. Artillery is an area weapon, causing localized but disparate damage across the targeted area. Attacks of this nature leave clear evidence, predominantly through impact craters. There are no craters visible in the image dated 27 February 2026 either in the area with debris or outside it, and no other areas of damage. An analysis of the provided handheld imagery does not show damage consistent with, or evidence of artillery strikes.

Analysis in this case does show damage, but does not support the claim that the area was struck with artillery.

There is no evidence that the Ferosplavna 330kV open switchyard was attacked twice by a relatively large amount of artillery fire. A visible lack of craters across the area in imagery dated 27 February 2026 supports this assessment. There is debris present in one 800sqm area which is corroborated by supplied handheld imagery, but this again does not support the claim that the area was hit with artillery, just that there is broken equipment present.

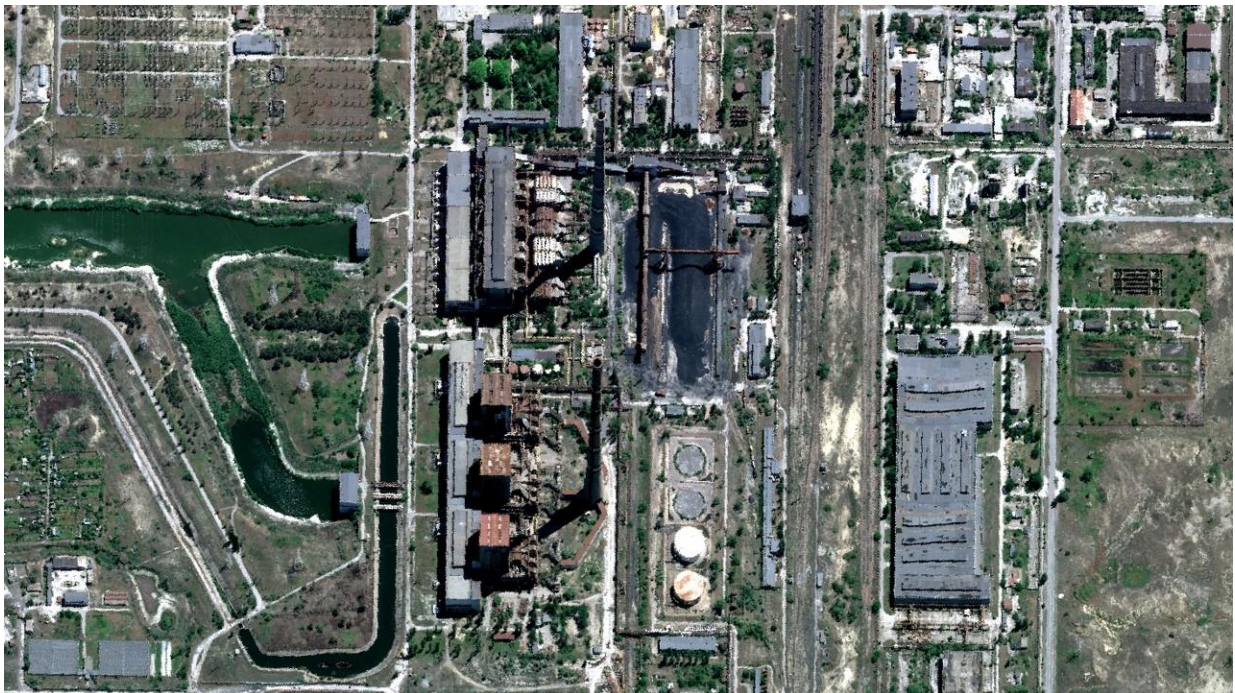
Fig.4 - Overview of the Zaporizhzhia Thermal Power Plant (ZTPP). Image dated 22 May 2026

There was no evidence of claimed drone strikes against the ZTPP in images dated 6 and 13 June 2026. Damage was noted on several buildings in the wider ZTPP, but analysis of imagery dated 15 October 2025, 27 February 2026 and 22 May 2026 showed this damage was present prior to June 2026. There was no significant visible change in the levels of damage across the entirety of all the buildings that make up the ZTPP. The ZTPP is located approximately 2km east of the ZNPP. See Fig. 4 below.

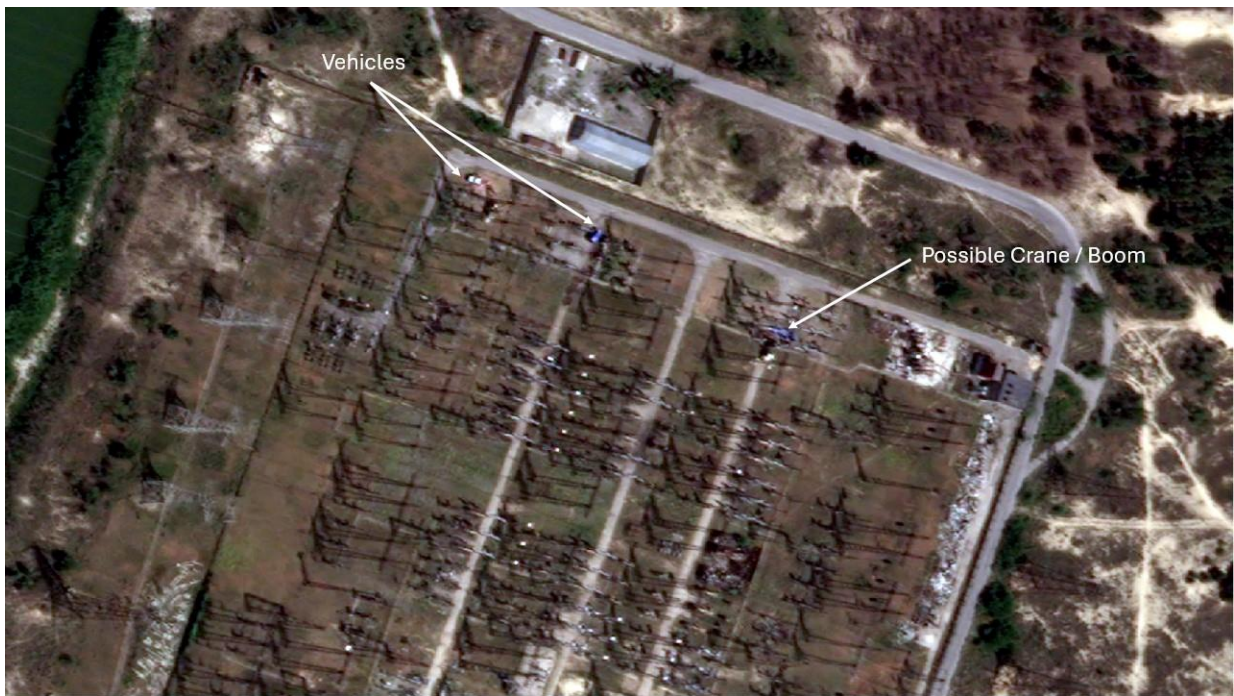
Fig.5 – Activity in Ferosplavna 330kV open switchyard area on 6 June 2026.

There were several instances of activity noted in the Ferosplavna 330kV open switchyard associated with the ZTPP. On 6 June 2026 several vehicles were noted in the northern perimeter of the yard. It is possible that one of these vehicles was equipped with a crane / boom. See Fig. 5 below. There are no visible craters indicating an attack has occurred.

There is no evidence of drone strikes against the Zaporizhzhia Thermal Power Plant (ZTPP) or the area around the facility in the two images captured after the supposed 4 June 2026 strikes. With at least three vehicles present across several areas of the transmission yard / step-up area on 6 June 2026, it is possible that this may have been normal service of the equipment. The presence of vehicles including four probable cranes / booms, concentrated in one area, noted on 13 June 2026, may have been replacement of equipment. It cannot be determined if this activity was routine, planned, or because of an attack against this part of the facility. The lack of visible evidence of an attack on either image post 4 June 2026 supports the assessment that an attack consisting of 20+ drones did not occur.

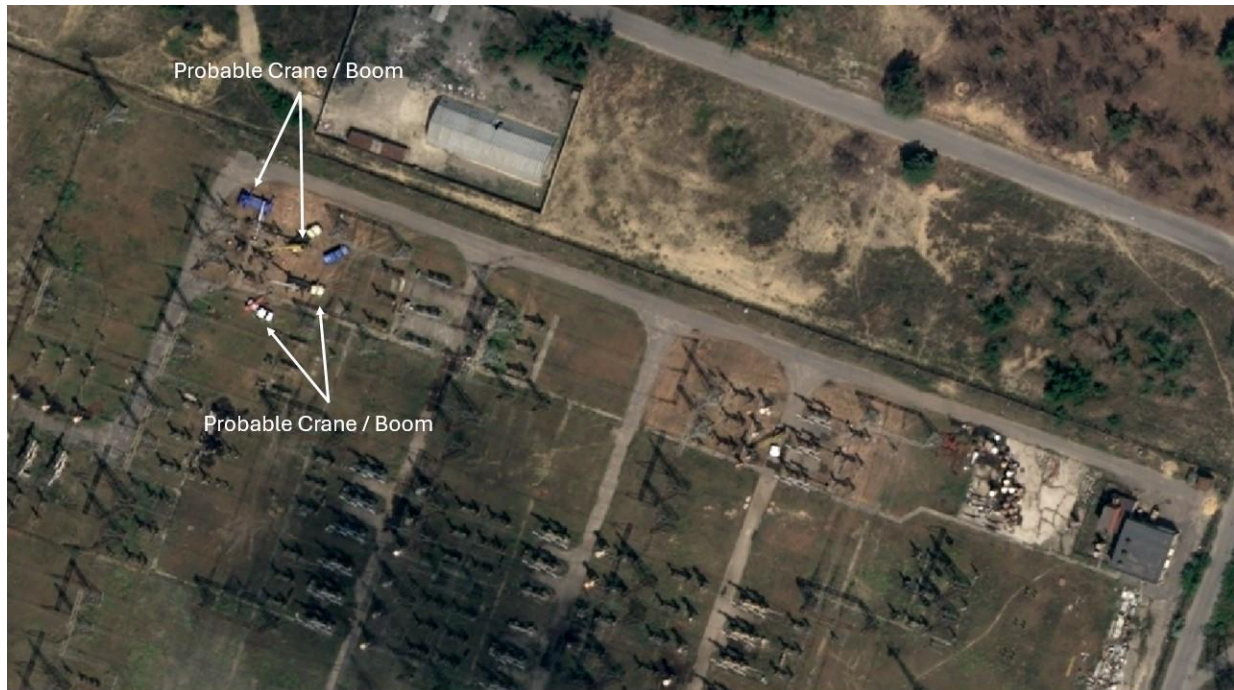
Fig. 6 – Activity noted on 13 June 2026.

Activity was noted in the same area on 13 June 2026. On this occasion, vehicles were clustered in one location with four probable cranes / booms and another vehicle in attendance. There remains no evidence of strikes in the location. See Fig. 6 below.
